**STS-109 (BI111)
FLIGHT READINESS REVIEW**

February 14, 2002

Solid Rocket Booster

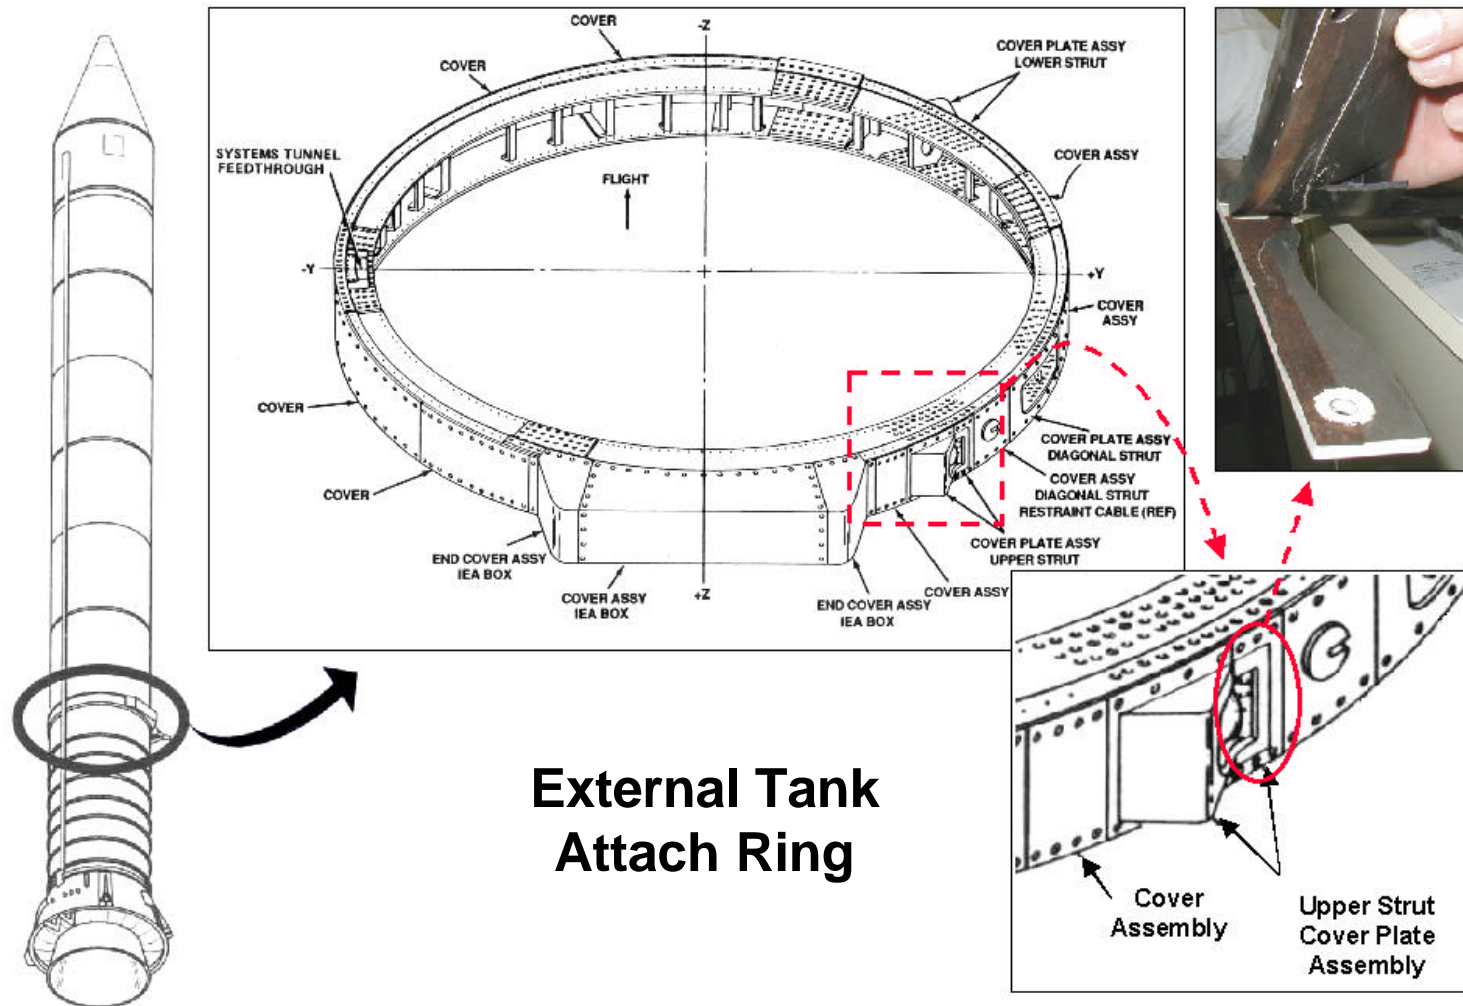
**External Tank
Attach Ring**

- Suspect corrosion exists beneath rubber and paint on all Ethylene Propylene Diene Monomer (EPDM) covers

- STS-109/BI111 EPDM RH upper strut cover adhesive failed with evidence of corrosion at adhesive bondline
 - Discovered during EPDM strut cover installation in VAB
 - Cover removed and replaced

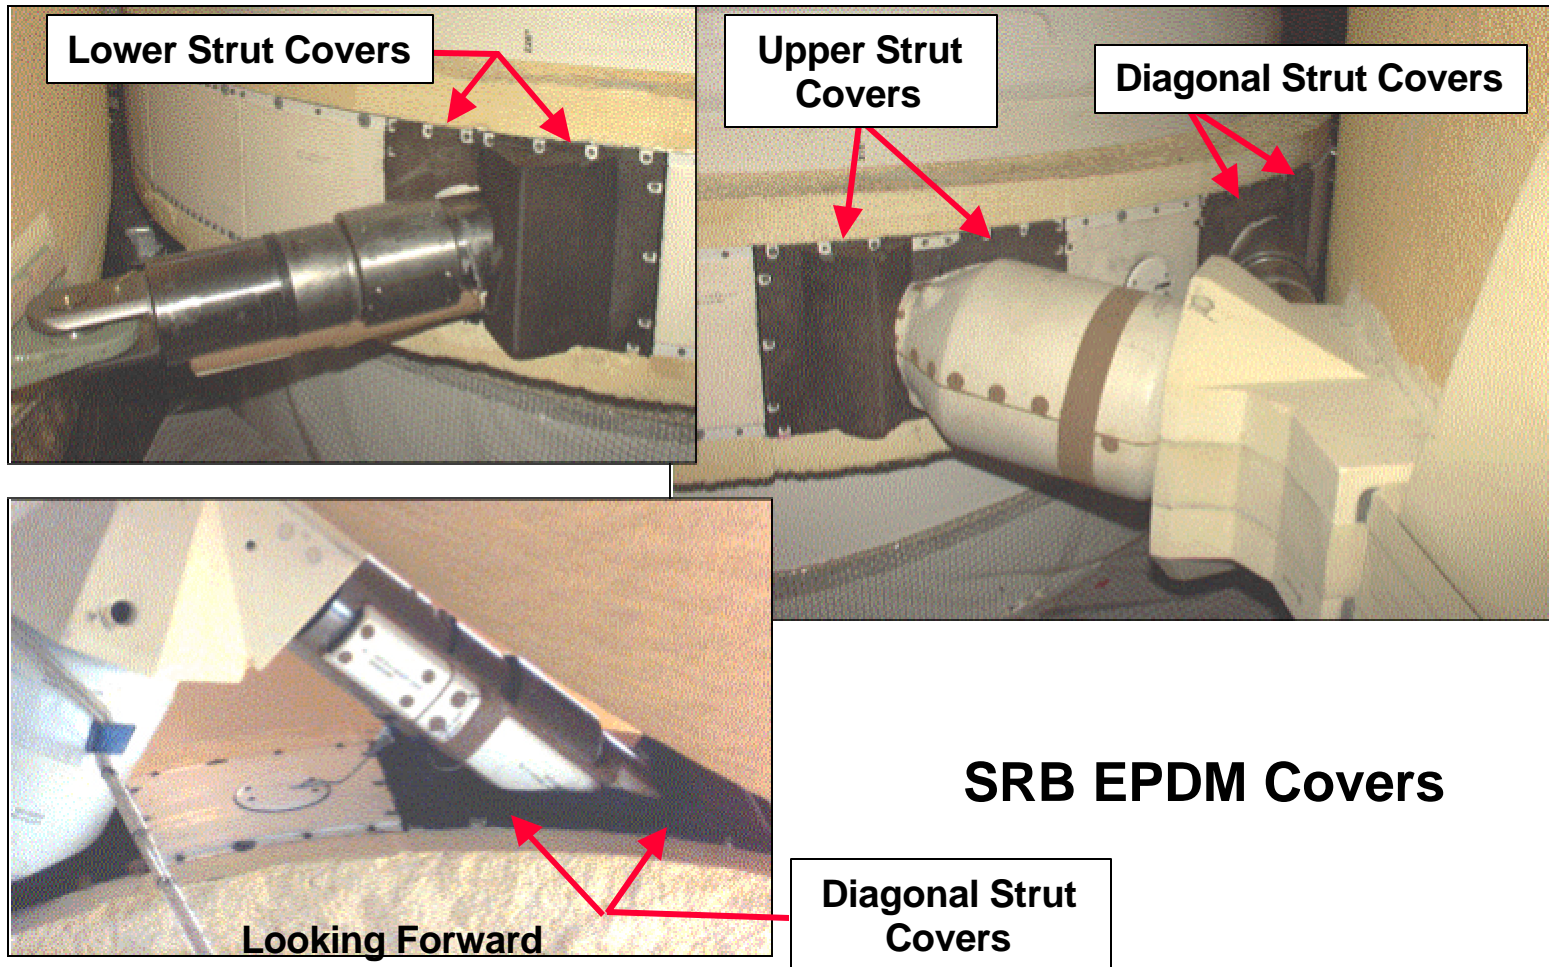
SRB EPDM Covers

- Stock sweep performed on in-stock and flown STS-108 covers
 - Visually inspected all covers
 - Hand applied fold back bond test performed on uninstalled covers
 - Materials testing performed
 - Bond strength
 - One additional in-stock cover failed bondline screen
 - Low bond strength evident over full cover bond
 - Corrosion
 - Maximum depth = 0.001 inches
- All STS-109/BI111 covers inspected in place
 - One additional cover failed inspection
 - Removed and replaced
 - Localized repairable debond

- Inspection of all installed covers reveals no indication of debonds nor visible signs of corrosion
- Two debond failures identified as isolated cases of low bond strength
- Cover installation and ET/SRB mate loads on EPDM rubber screen for sufficient bond strength
- STS-109/BI111 safe to fly with no increase to flight risk

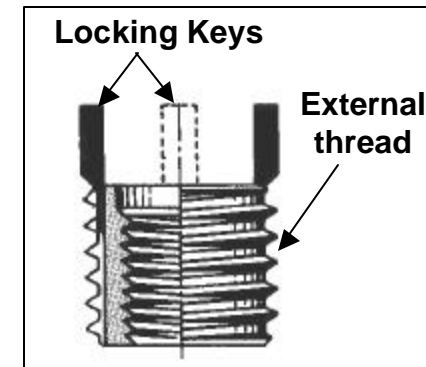
Keensert (Typical)

- Port cap/front housing interface utilizes threaded Keenserts to mate with bolts
 - Provides greater strength due to increased shear area
 - Prevents wear on aluminum housing threads

- SRB pumps refurbished by vendor following every flight
 - Includes visual inspection of threaded Keenserts
 - Occasional Keensert replacement required
 - Replacement results in decreased shear area due to reclocking of locking keys
 - No SRB STS-109 pumps contain replaced Keenserts
 - ATP includes multiple functional checks of suspect joint
 - Proof pressure = 4875 psi (1.5x rated operating pressure)
 - Extensive run time (~8 hrs) with multiple leak checks
 - No indications of pump failure due to housing thread shear
 - Potential incident of stripped threads documented (1999)
 - No evidence of external leakage or performance degradation
- Conservative analysis results in positive margin of safety

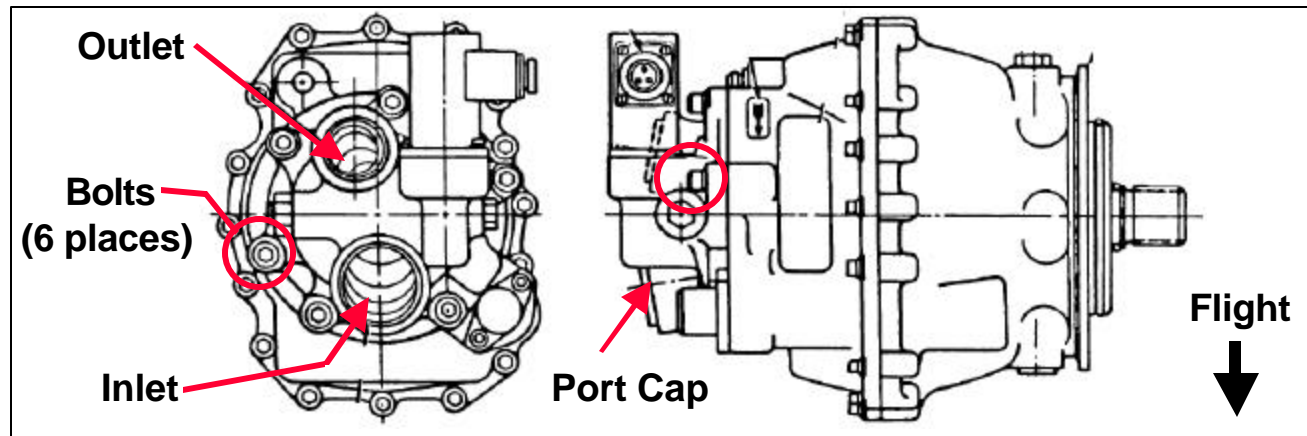
Hydraulic Pump

- Orbiter Project noted discrepancies in hydraulic pump port cap fastener vendor analyses
 - Calculations utilize high coefficient of friction
 - Questions validity of pump qualification/certification analysis

- Two design configuration differences between Orbiter and SRB hydraulic pumps
 - Fastener material finish
 - Orbiter design uses passivated bolts without dry film lubricant
 - SRB uses non-passivated bolts with dry film lubricant
 - SRB uses corrosion-inhibiting compound
 - Orbiter bolts installed dry

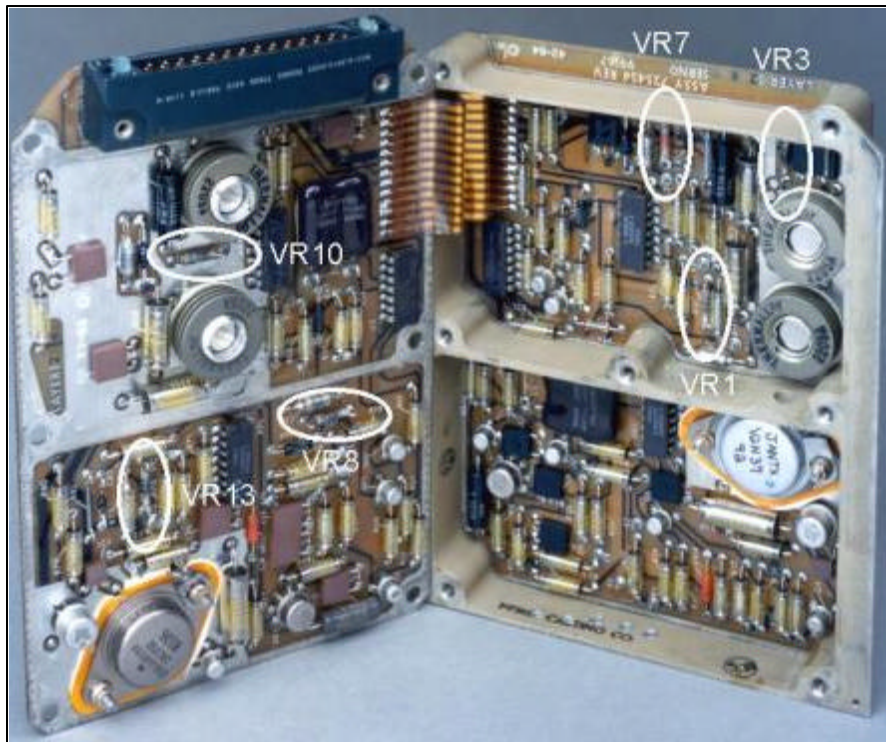
SRB APU Controller Card (Typical)

- Integrated Electronics Assembly (IEA) S/N 025 failed APU BITE test during final acceptance functional test at vendor
 - APU controller Fuel Shutoff Valve (FSV) command alternating between 28 VDC and 0 VDC with BITE frequency applied
- Isolated fault to open Zener diode on APU Controller (APUC) module S/N 158
